EAST HEAD

V.J. May

OS Grid Reference: SZ761985

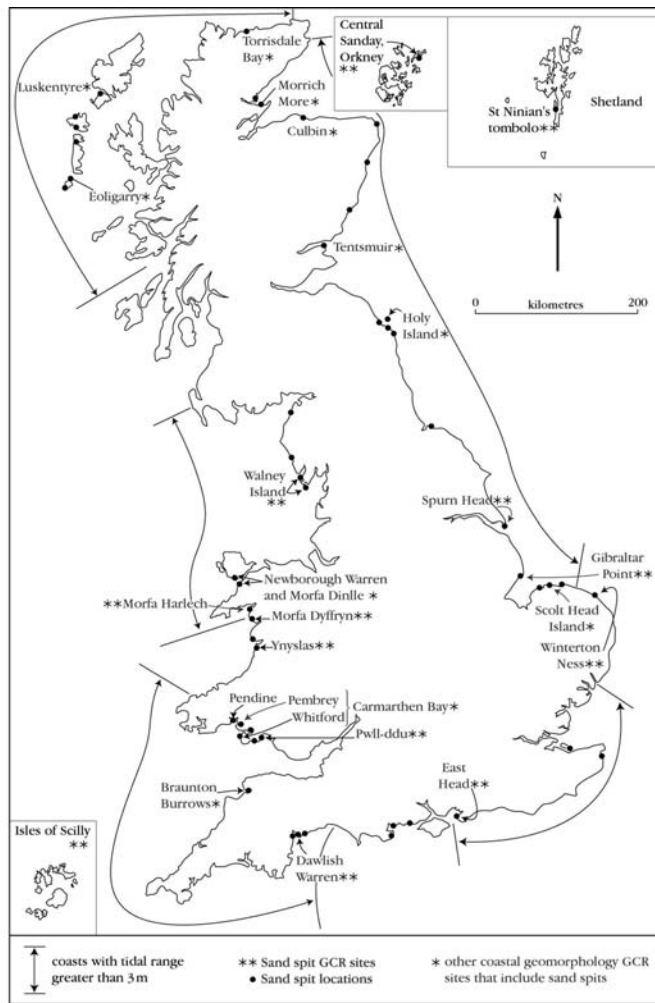
Figure 8.2: The location of sand spits in Great Britain, also indicating other coastal geomorphology GCR sites that contain sand spits in the assemblage. (Modified after Pethick, 1984).

East Head is a low ridge of sand-dunes and beaches that lies on the eastern shoreline of Chichester Harbour whose mouth it restricts (see Figure 8.2 for general location and Figure 8.6). Despite extensive interference with the process of longshore drift by groynes to the east, this site has been dominated by accretion during its recent history. In common with several other such features, it has a broad distal end, partly formed by recurves, and a narrow neck at its landward (proximal) end. Unlike many such features, it has prograded steadily even though there has been breaching of its neck. Today its volume is probably greater than at any previous period. Its development appears to be associated with changes in the intertidal 'delta' at the mouth of Chichester Harbour. Shingle ridges, which successively change orientation from NNW–SSE towards NE–SW, form the base of the dunes, which attain about 3.5 m in height. The area of the spit, which declined steadily during the 19th and early 20th centuries, has increased since 1972. Cartographic evidence suggests that a comparable period of progradation after progressive lateral migration of the spit also occurred during the 18th century. Like many of the shingle spits of the central south coast of England, East Head is paired with a spit on the opposite side of the estuary, but it has received less attention until recently. Searle (1975) outlined its key features and particularly the effects of occasional recent breaches in its form. Examination of the cartographic evidence during the last 200 years coupled with more recent aerial photography suggests some unusual features about the development of the spit, not least because what has appeared to be an erosional phase is in reality a depositional one.

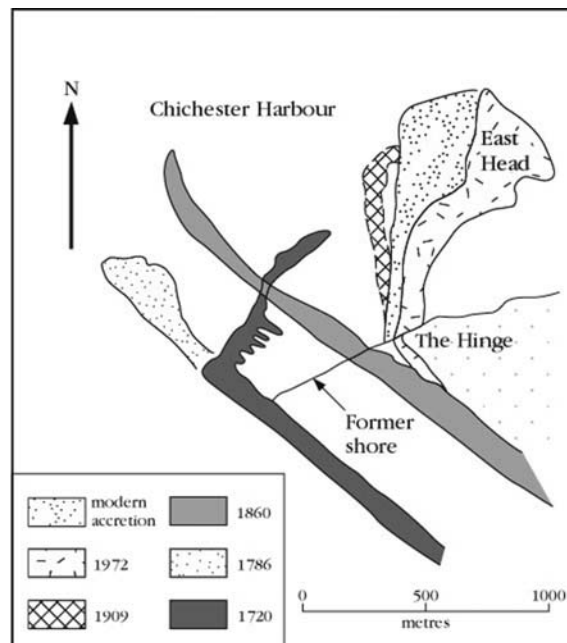
Figure 8.6: Historical changes at East Head. (After May, 1975.)

The form of the spit appears to have been of two types that appear to alternate. The first (Type A) is a long narrow ridge, the second (Type B) a narrow ridge turning landwards leading to a broadly triangular distal end. Thus Type B appeared first and was replaced by Type A by the mid-18th century. This was subsequently breached. From about 1760 to about 1850, Type B predominated, whereas Type A was the dominant form until 1933 and was breached several times (Ramsay, 1934). Type B then became established once more. Steady erosion reduced the spit to its narrow form, which was breached in 1963. The establishment of groynes to the east may have been an important factor in speeding the onset of breaching. Since 1963, the more stable Type B has been the characteristic form (see Figure 8.6).

After 1965, there was a marked increase in sand seaward of the old vegetated ridge of the dunes (Figure 8.6) and there was also considerable intertidal accretion that provided a source of windblown sand for the dunes. Harlow's (1982) sediment budget analysis for this coastline confirmed that this sand supply and the changes in intertidal areas of East Pole, West Pole and The Winner are related.
