SOLWAY FIRTH (NORTH SHORE)

J.D. Hansom

OS Grid Reference: NY003668–NY118652

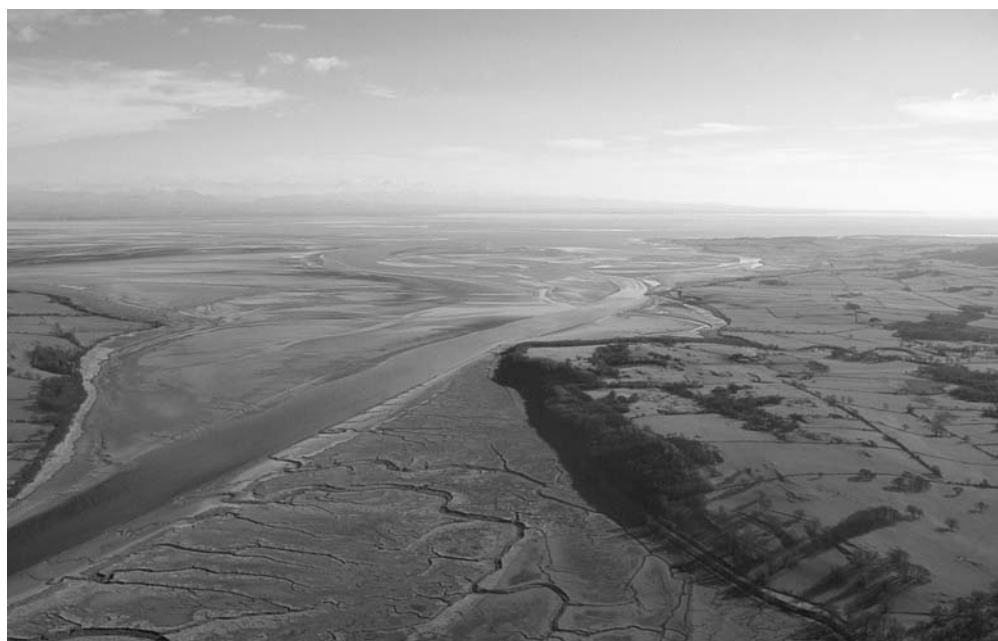
Figure 10.13: A view looking south over Kirkconnell Merse on the west side of the River Nith towards Airds Point in the middle distance and Southernness beyond. The saltmarsh is grazed and is crossed by many well-developed creeks that drain to a prominent terrace along the Nith. Part of the saltmarsh of Caerlaverock can be seen on the east side of the river and to the south lie extensive sandflats. (Photo: P. and A. Macdonald/SNH).

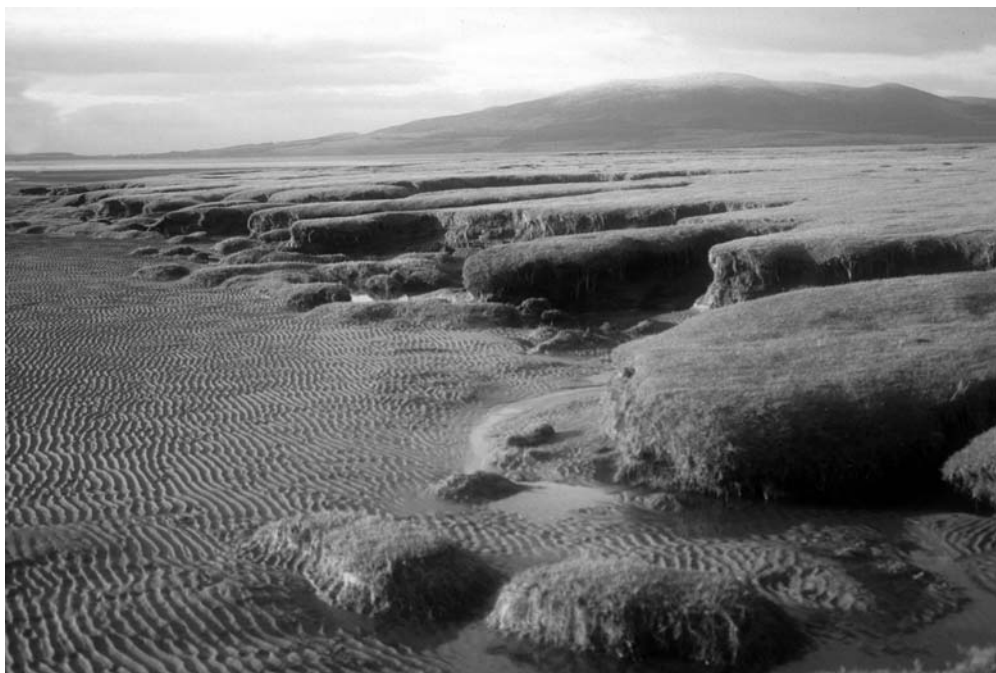
Figure 10.15: Erosion on the west side of Caerlaverock saltmarsh. 1 m-high erosional terraces cut into the *Puccinellia*-dominated high-marsh surface are common on this shore but in places exposed to south-westerly wave activity, they are also subject to further surface-stripping of vegetation. (Photo: J.D. Hansom).

Merse showed a net increase of 51 ha between 1946–1973 (Rowe, 1978), a rate of about 2 ha per year. Over the same period, the west of Caerlaverock has undergone edge erosion via toppling failure of large blocks of saltmarsh sediment by undercutting at high tide during storm conditions. Even in this relatively sheltered part of the Solway, the short and steep waves that impinge on the saltmarsh edge are capable of significant erosion of unconsolidated sediments, and the stripping of layers of sediment and vegetation from the top surface of the terrace.
